TOURISM AND PROTECTION OF HISTORIC CITY CENTRES

THE CASE OF PLAKA IN ATHENS

Dionysis A. Zivas

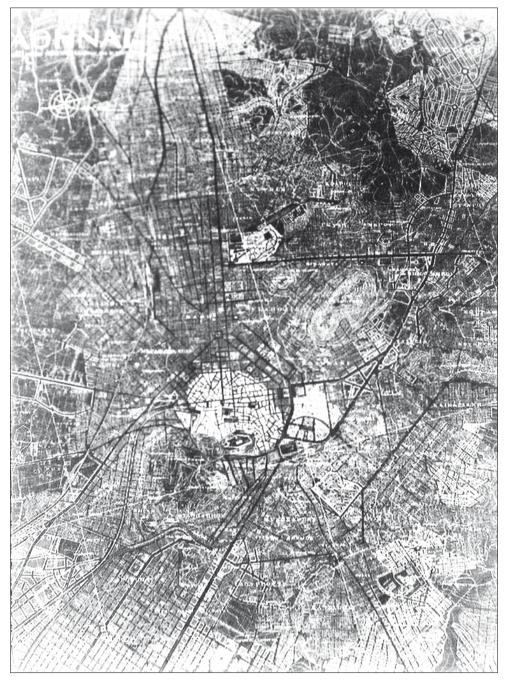
Fig. 1 Athens in the early $19^{\rm th}$ century (in white), compared to a part of contemporary Athens.

Plaka, the oldest known neighborhood of Athens, is today what we could call the core of the historic centre of the Greek capital. In all respects it is a neighborhood that is linked closely with the history of Athens, since it has been inhabited continuously from the Late Neolithic period (3000 BC) to the present day, that is for some five thousand years. Indeed, in the darkest periods of the city's history, Plaka was Athens itself (*Fig.* 1).

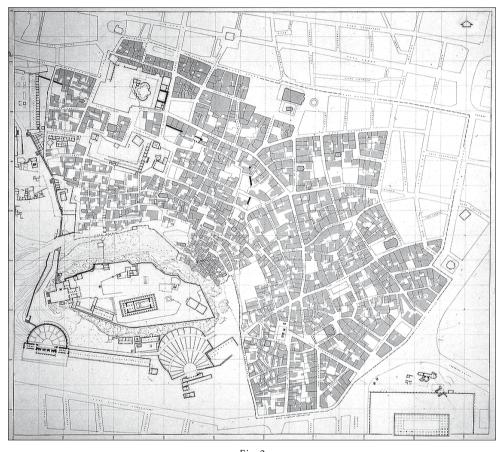
Fig. 2 Plaka today.

Plaka embraces the lower north and east slopes of the rock of the Acropolis. It is roughly semicircular in shape, about one kilometer long and 350 m in average width (*Fig.* 2).

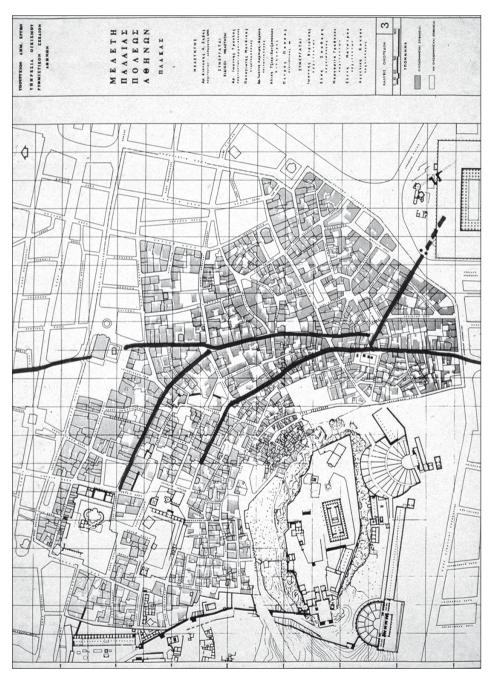
Fig. 8 - Earlier streets (in black) that still exist in contemporary Plaka.

Precisely because of its location and its history, Plaka is an extensive settlement-monumental ensemble, which includes monuments from all periods of Greek history (*Figg. 3-7*). It is also an ensemble that has kept the urban structure and organization of much earlier periods. Some of the surviving monuments and the archaeological finds indicate that at least some of today's streets in Plaka already existed in Classical times (*Fig. 8*).

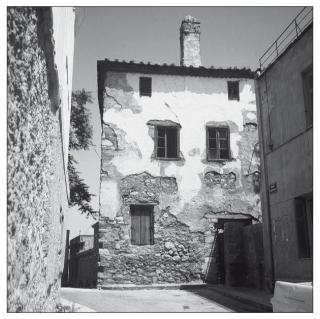
Fig. 9
Tower-house of the late 18th century.

After the Liberation of Greece, the residents of Plaka began rebuilding their houses, which had been destroyed in the War of Independence. They almost kept the same street plan and followed the traditional types of Athenian popular houses, although gradually accepting and incorporating influences from Neoclassicism, which had already appeared in Greece, introduced here by Bavarian architects (*Figg. 9-13*).

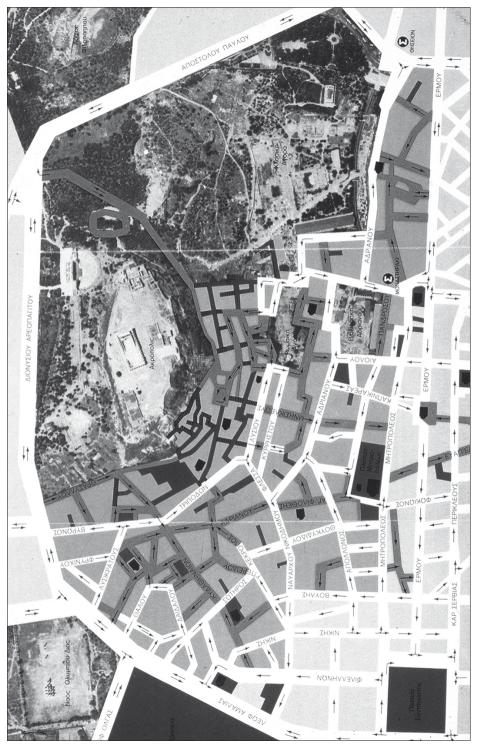
Fig. 21 - The circulation system for pedestrians and vehicles in Plaka. Pedestrian precincts are marked in green.

- a. To apply certain measures which would have an immediate and, if I may say so, «impressive» result. The first such measure was to apply a new circulation system for pedestrians and vehicles in Plaka. So, 50% of the overall length of streets in Plaka became pedestrian precincts, which meant the vertical drop in motor traffic, with the corresponding decrease in noise and pollution, and the restoring of a large part of the streets of the neighbourhood to their original functional character (*Fig. 21*).

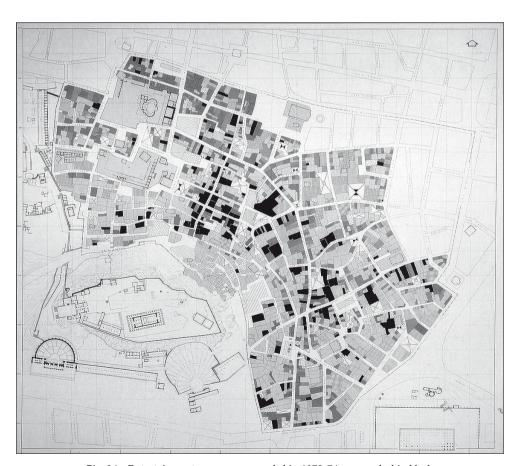
Fig. 24 - Entertainment venues, as recorded in 1973-74, are marked in black.

and to adopt strict rules for the operation of entertainment venues. It should be noted here that 190 such venues, with an overall capacity of 18,000 clients, had been counted in 1973-1975 (*Fig.* 24).

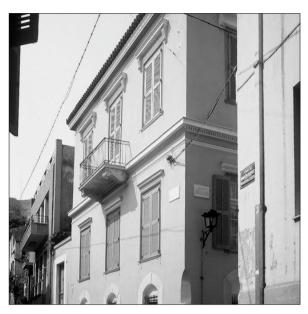
Fig. 30 Restored house near the Roman Agora, now functioning again as a residence.

The laying out of the pedestrian precincts, which were paved with natural marble slabs, so restoring them to their original form, as well as of the open spaces in general was completed. All the electricity cables above ground were removed and all the streetlights were replaced by replicas of old gaslights. The Ministry of Public Works funded owners who repaired the façades of their houses and, through the National Mortgage Bank of Greece, low-interest long-term loans were granted for the restoration of historic buildings. The noisy night clubs and entertainment venues that had made the residents' life unbearable were obliged to relocate or to conform with the new terms of operation, and numerous buildings were restored and re-inhabited, giving back to Plaka its old physiognomy (*Fig. 25-30*).
